NOMINATION FORM  
for the  
NATIONAL REGISTER OF HISTORIC PLACES, NATIONAL PARKS SERVICE

<b>1. NAME</b>				
COMMON:				
Harvey House				
AND/OR HISTORIC:				
<b>2. LOCATION</b>				
STREET AND NUMBER:				
Route 1, 1/2 mile north of old U.S. 40, 6 miles west of Hancock				
CITY OR TOWN:				
Hancock				
STATE		COUNTY:		
Maryland		Washington		
<b>3. CLASSIFICATION</b>				
CATEGORY (Check One)		OWNERSHIP		STATUS
<input type="checkbox"/> District <input type="checkbox"/> Building <input type="checkbox"/> Site <input type="checkbox"/> Structure <input type="checkbox"/> Object		<input type="checkbox"/> Public <input type="checkbox"/> Private <input type="checkbox"/> Both		<input type="checkbox"/> Occupied <input type="checkbox"/> Unoccupied <input type="checkbox"/> Preservation work in progress
		Public Acquisition: <input type="checkbox"/> In Process <input type="checkbox"/> Being Considered		ACCESSIBLE TO THE PUBLIC Yes: <input type="checkbox"/> Restricted <input type="checkbox"/> Unrestricted <input type="checkbox"/> No

WA VI-001 -- Description Continued

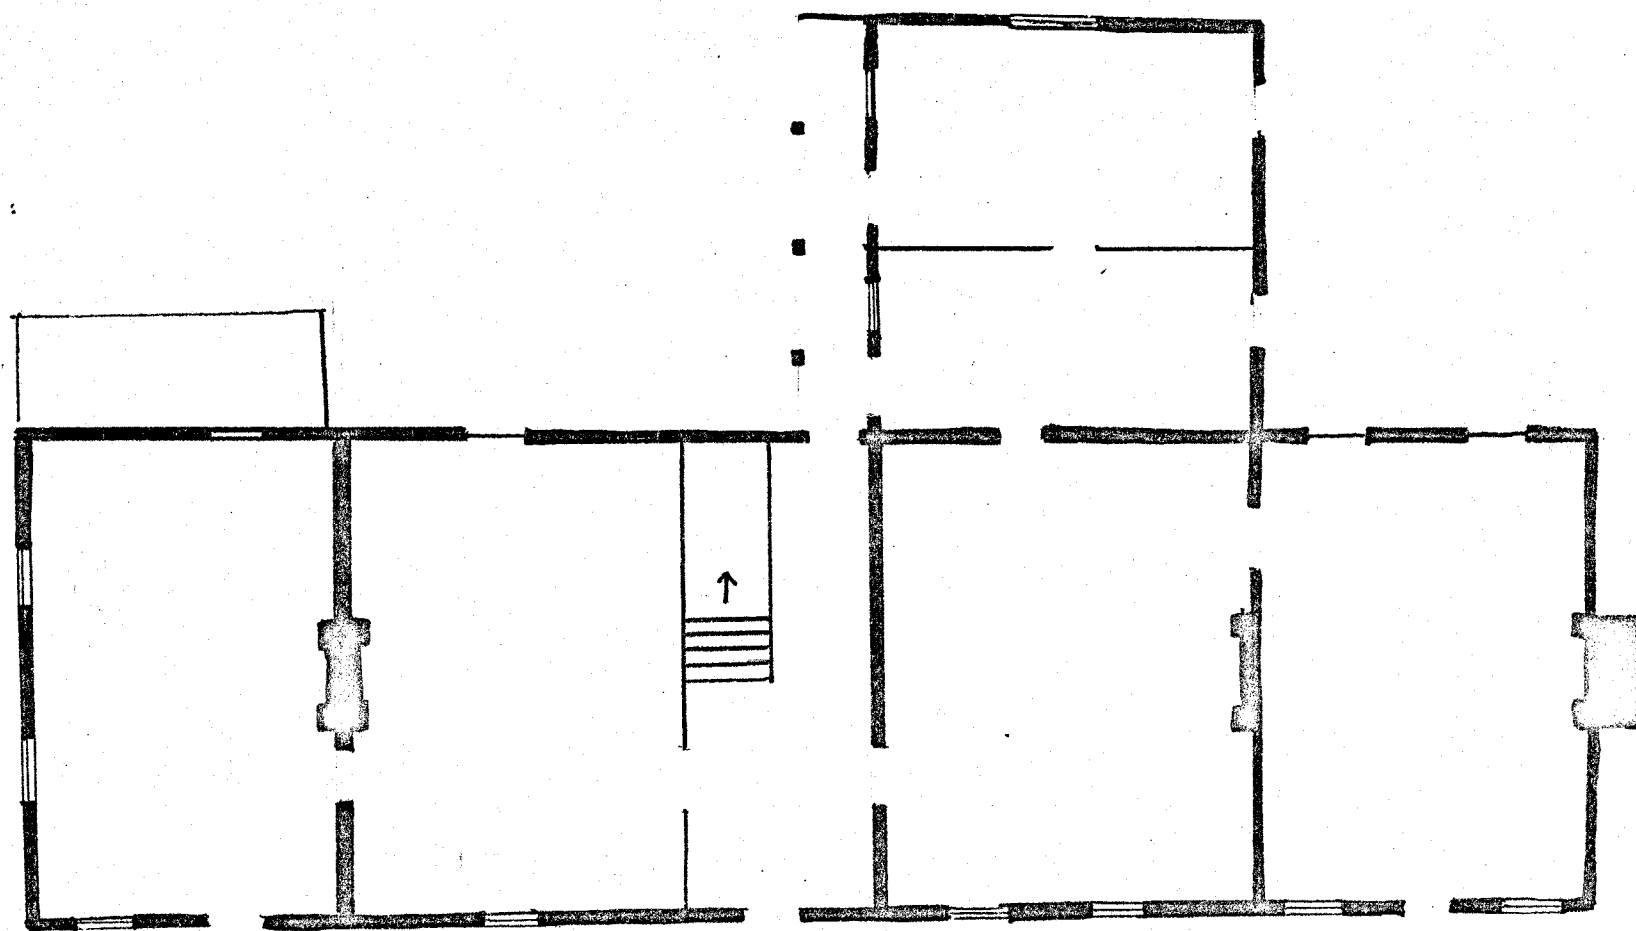
APPROXIMATE FLOOR PLAN

Parts of this house appear to have been built early in the 19th century. The floor plan suggests that the present hallway and the room to its south could have been added to the original structure, which may have included the room north of the stair and the wing,, and was reportedly used as the tavern.

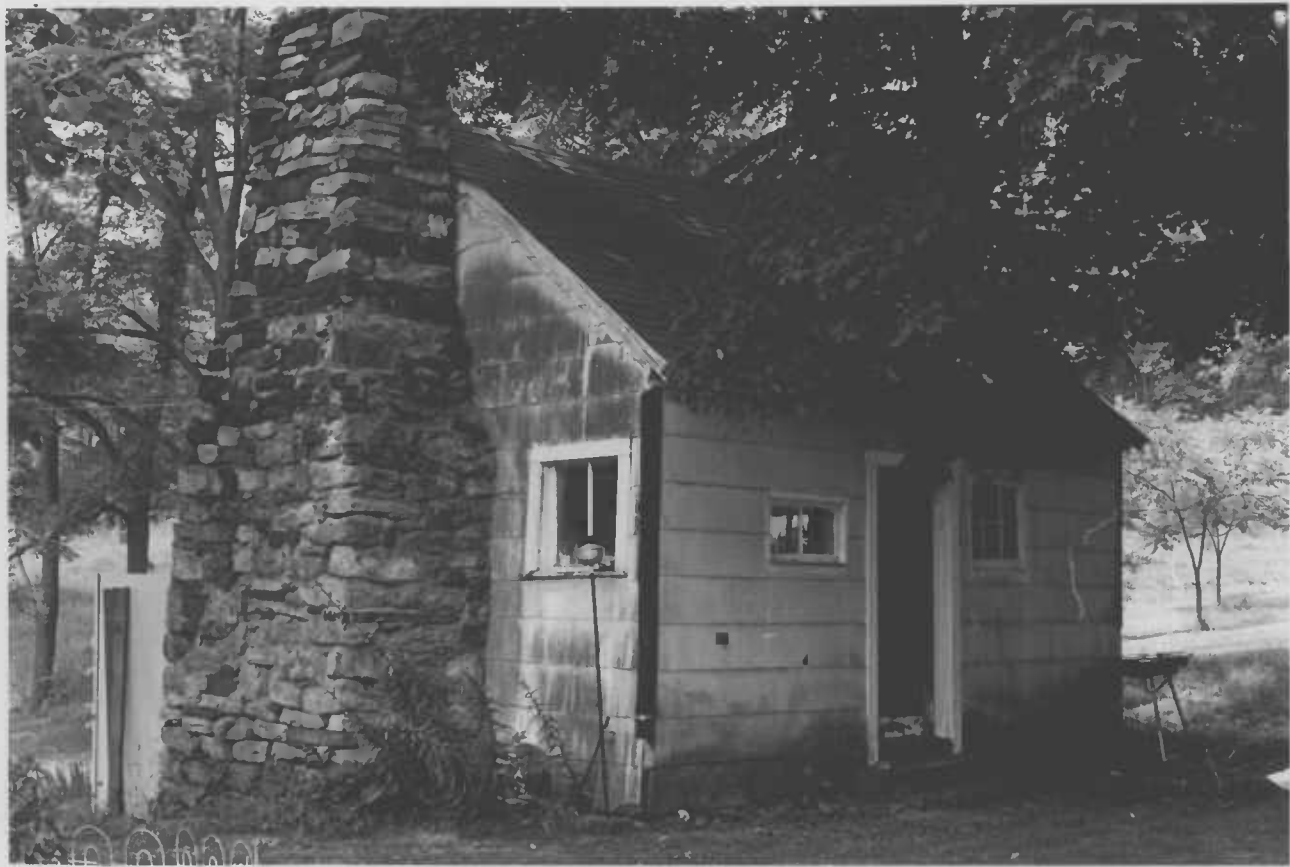
WA-VI-001  
WASHHOUSE  
S.E

Near this structure is a small frame wash house or kitchen with a stone exterior chimney. The buildings are in good condition and are not threatened by great exterior alteration or destruction. The property contains 352 acres and is used for agriculture.
